11. TITLE (Include Security Classification) Yatesville Lake, Big Sandy River Basin, Blaine Creek, KY Foundation Report, Construction of Dam and Appurtenant Works, Phase II Vol. 2

# YATESVILLE LAKE

## FOUNDATION REPORT VOLUME II

CONSTRUCTION OF DAM AND APPURTENANT WORKS, PHASE II

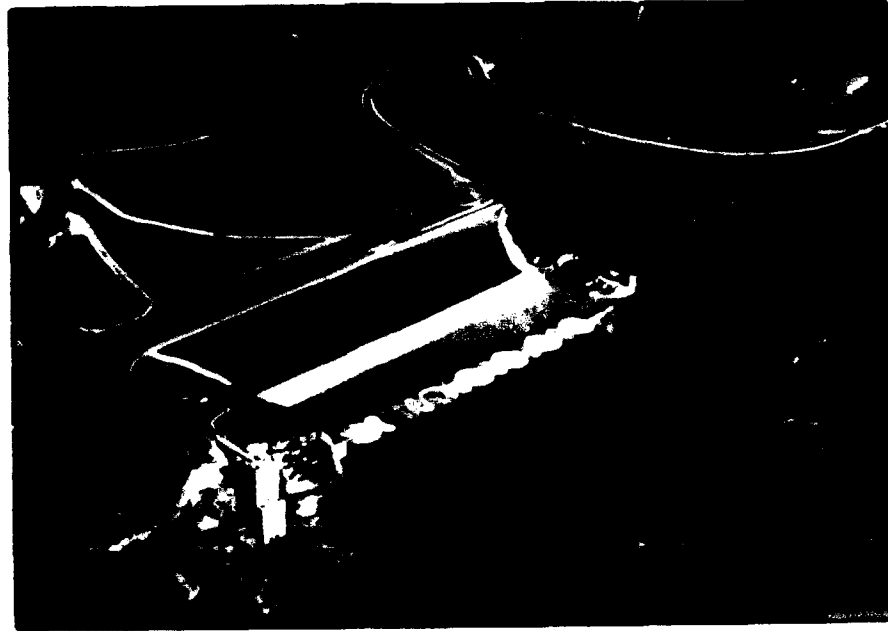
Dec 1988 - Nearly completed dam, cofferdam, intake structure and maintenance building, aerial photograph, viewed from upstream.
